Limited Visual Dam Safety Inspection Summary Report

MA-127

Napili 4-5 Desilting Basin

May 2006

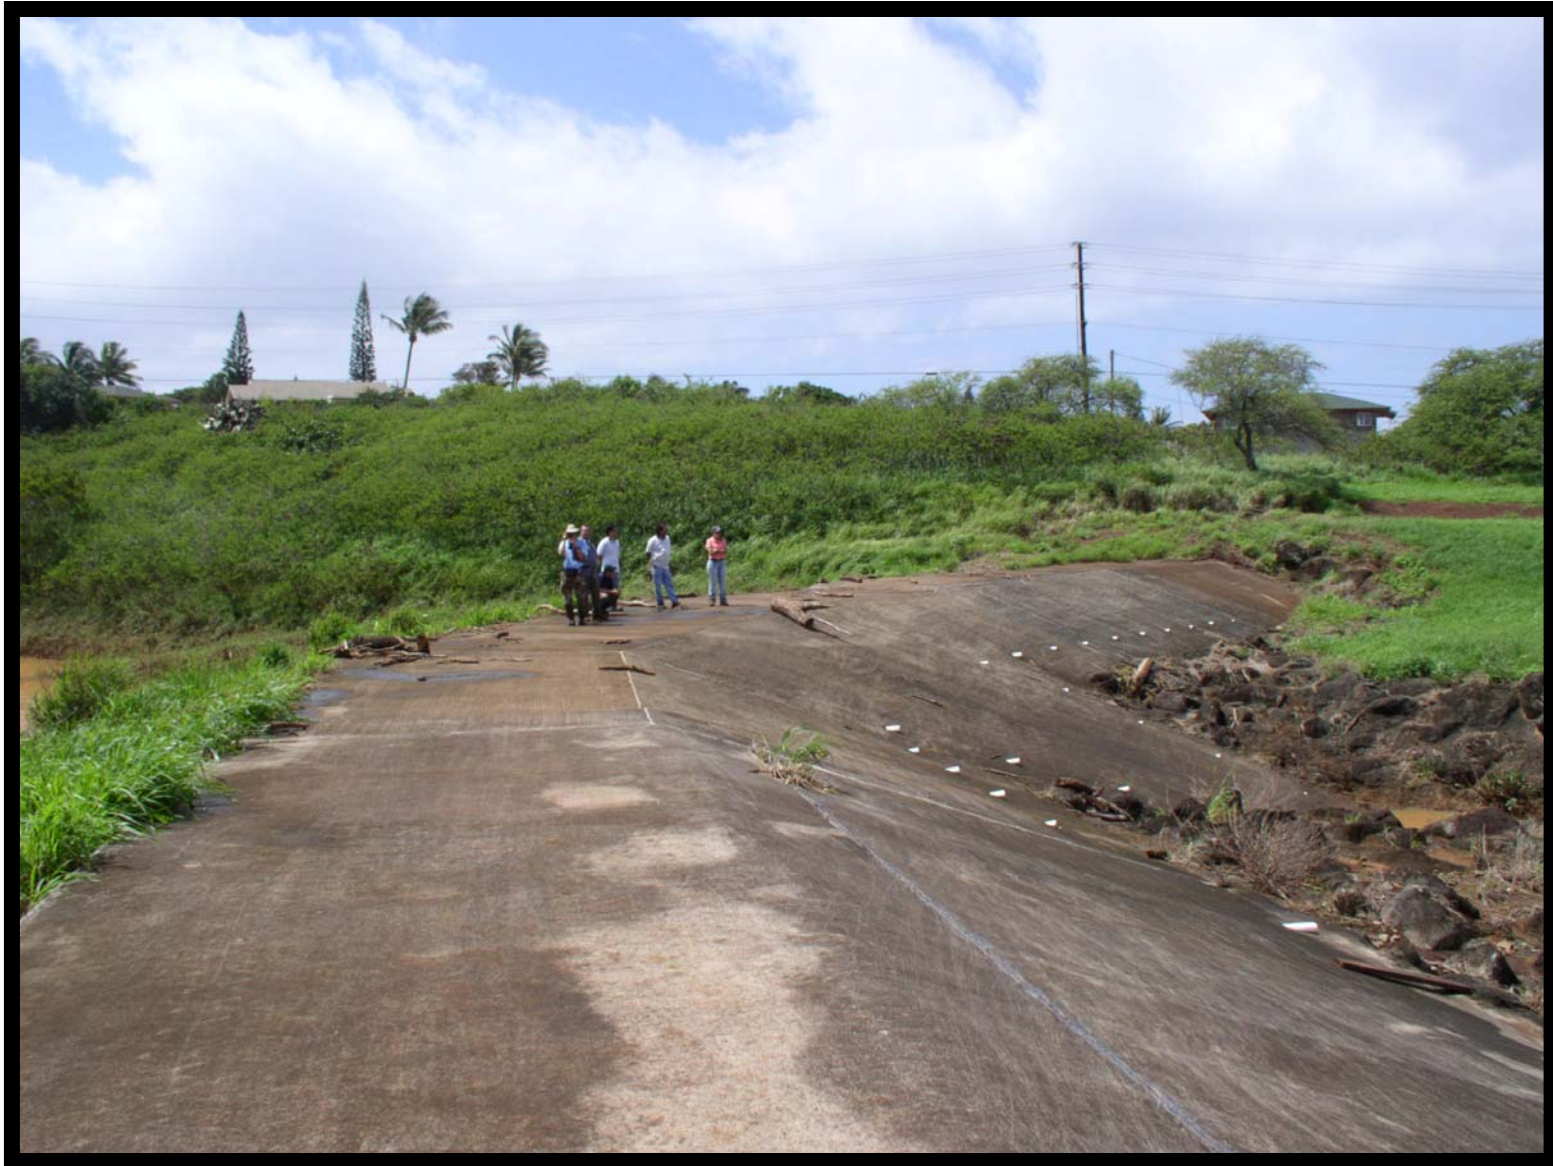
- a. The dam crest appeared to be in satisfactory condition. No corrective actions are required at this time.
- b. Access along the crest was satisfactory.

127 View of the crest of the Napili 4-5 Desilting basin

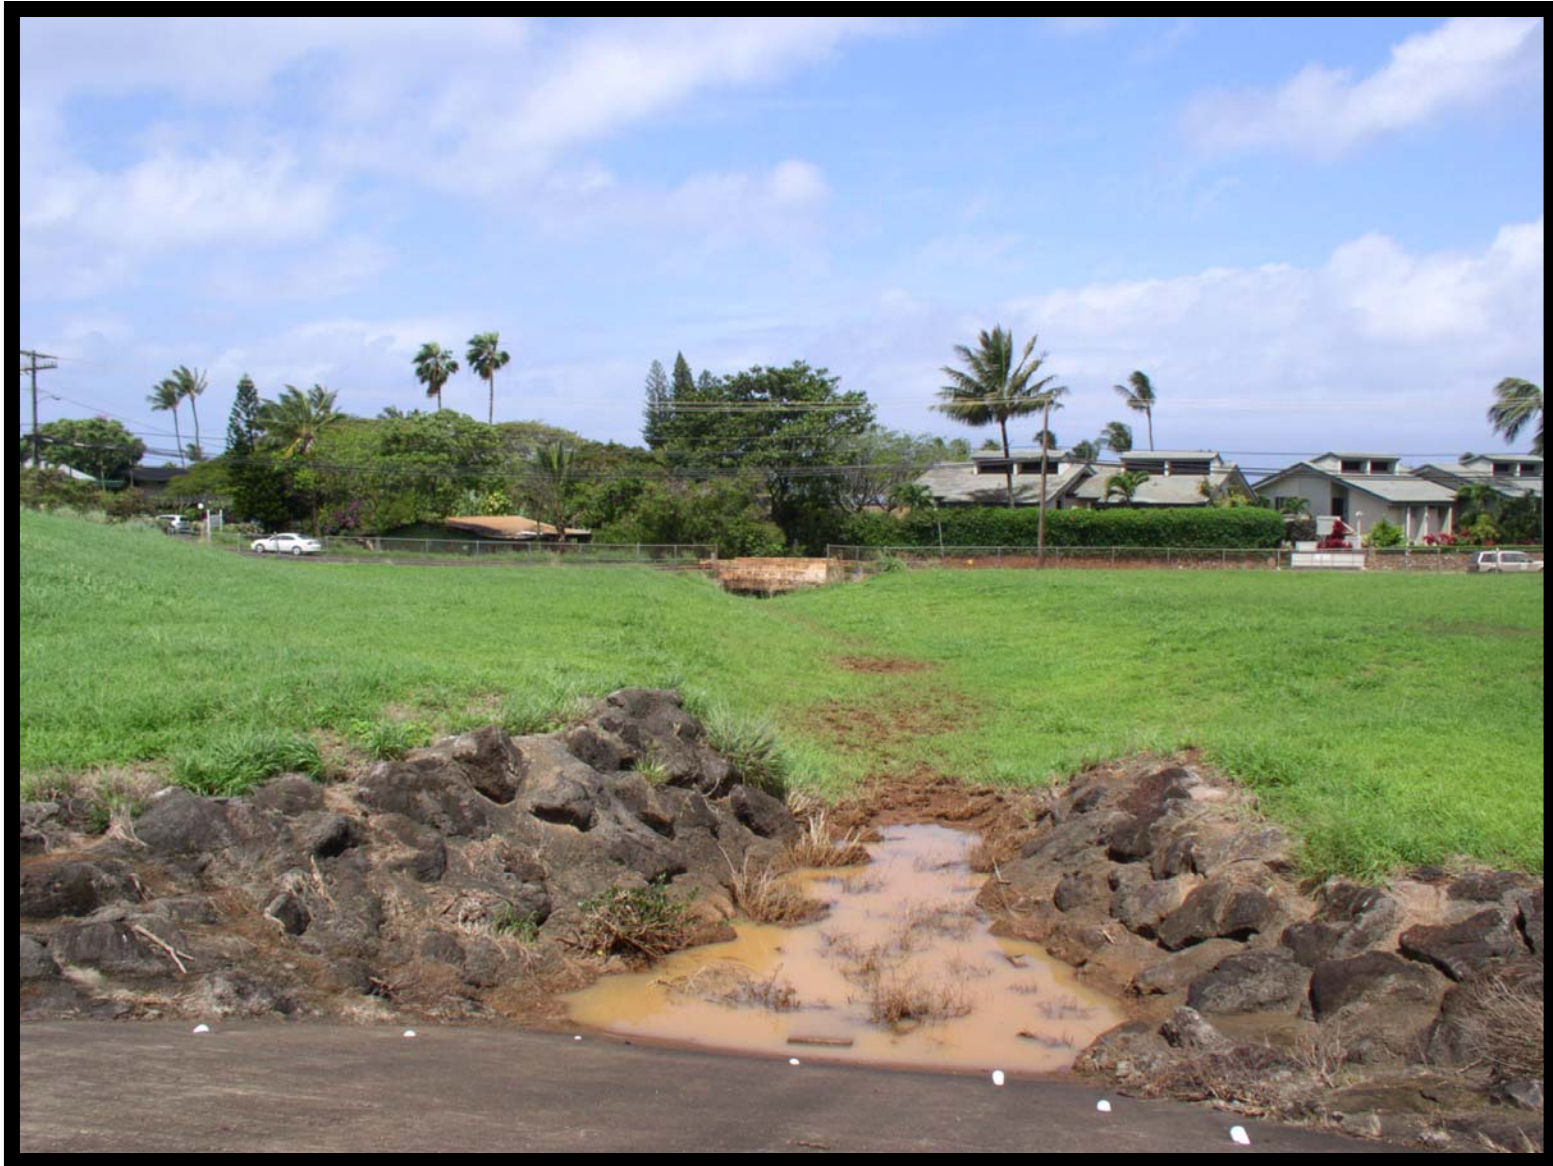
The outlet works consist of a 12-inch diameter concrete pipe. The control valve is broken – flow is uncontrolled.

127 Outlet - View of the outlet channel looking downstream
from the crest

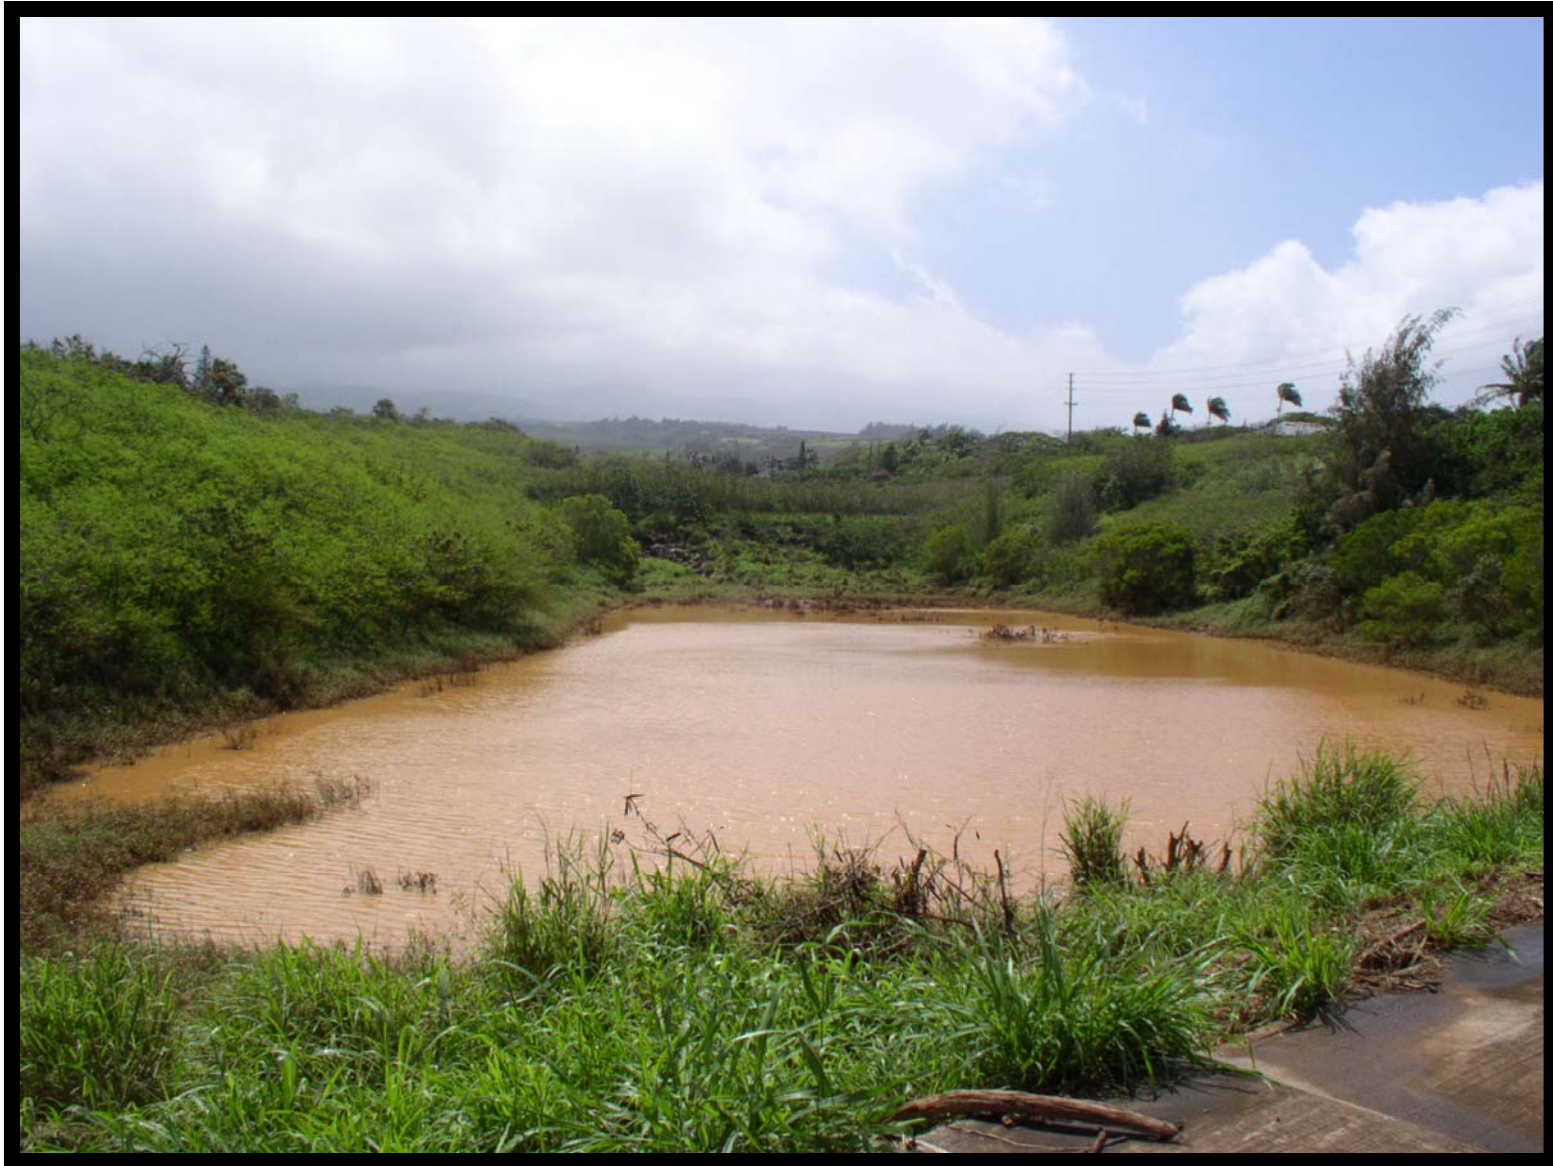
- a. The reservoir appeared to be in fair to poor condition and requires corrective action.
- b. A staff gage was not observed at this reservoir. Provide some method of quantifying the water level within the reservoir.

127 View of the dam reservoir taken from the crest

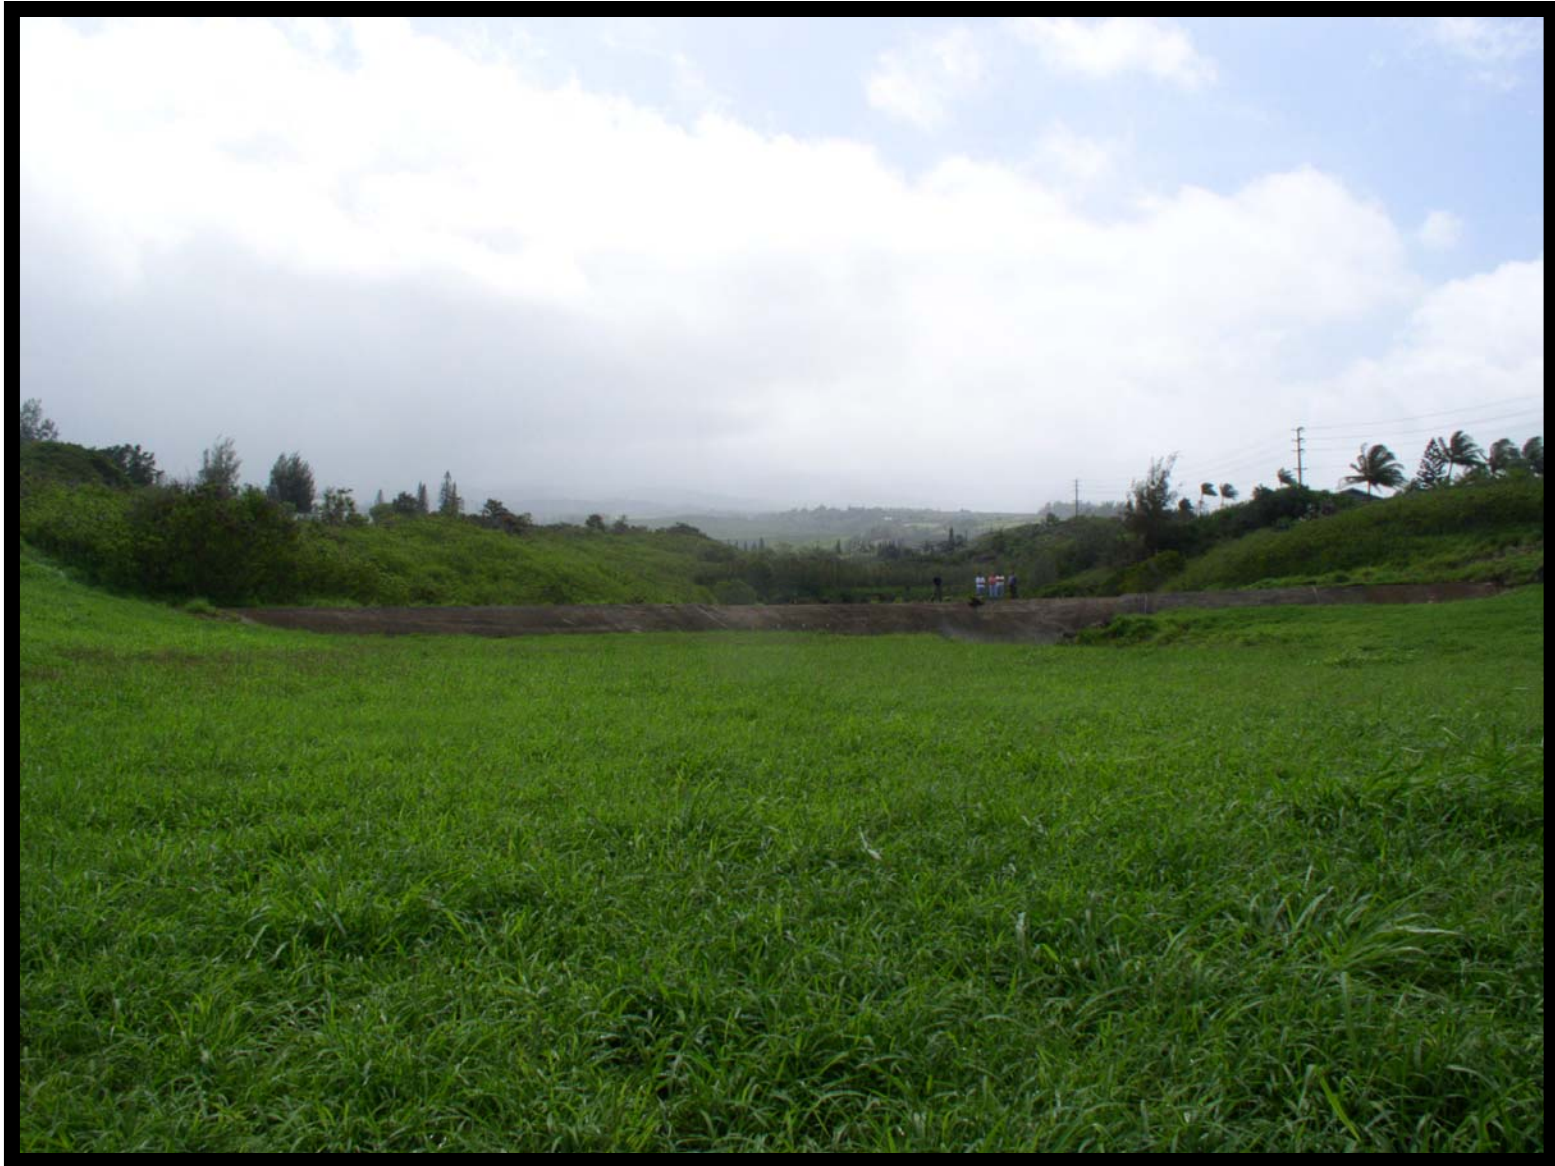
- a. The downstream slope appeared to be in satisfactory condition. No corrective actions are required at this time.

127 View of the dam looking from downstream of the dam
